# TEST REPORT

Sample name: VET 100 Circuit Analysis Tool  
Model: 3920  
Number of sample: 2pcs  
Sample Received: 2019-07-31  
Testing Period: 2019-07-31~2019-08-02

**Test project:** Sinusoidal vibration test**Test standard:** According to customer requirements**Test results: Please refer to next page(s)**

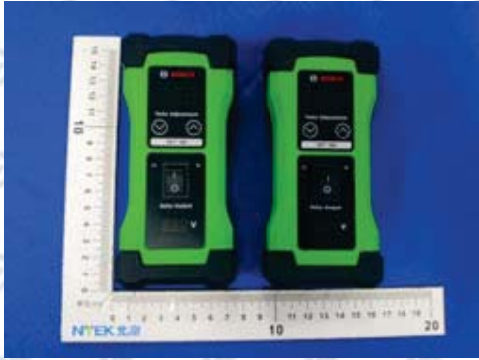
<p>Before test-1</p>	<p>Testing X axis</p>

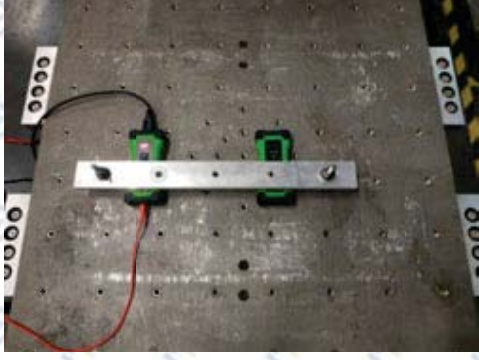
<p>Testing Y axis</p>	<p>Testing Z axis</p>

- 1) Sample test status: one power-on test, and the other power-off test;
- 2) Frequency: 30Hz/40Hz/50Hz/60Hz/70Hz/80Hz/90Hz/100Hz/110Hz/120Hz/130Hz;
- 3) Acceleration: 1.5g;
- 4) Test direction: X/Y/Z axis;
- 5) Test time: 30min/frequency point/axis.

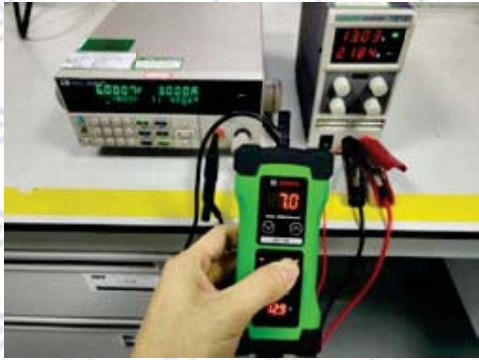
After test-2 (Function inspection)  
(190730033-005)

Sample No.	Test result		Criterion	Conclusion
	Visual Inspection	Function Inspection		
190730033-005 (power-on)	During the test and after the test, there was no obvious change on the appearance of the samples.	During the test and after the test, the sample function normally.	The appearance and functionality of the samples were normal during and after the test.	Pass
190730033-006 (power-off)				Pass
Note: The Criterion provided by client.

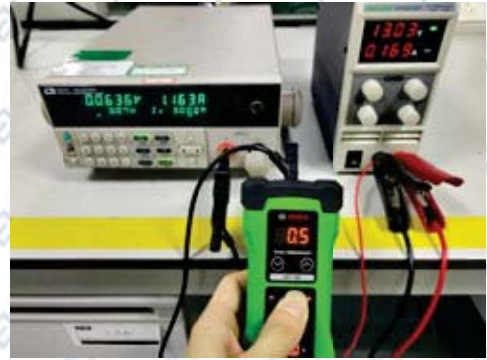
After test-3 (Function inspection)  
(190730033-006)

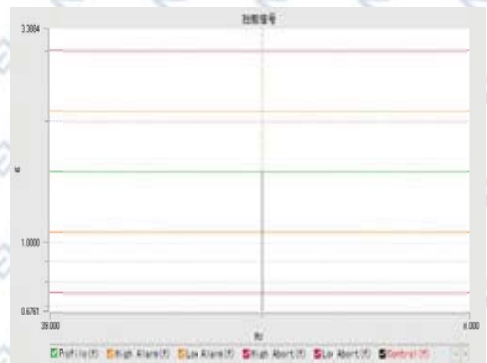
Test curve-2 (40Hz)

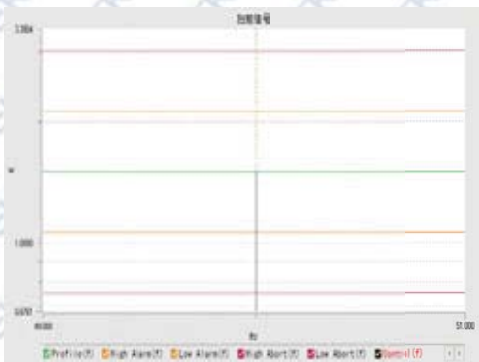
Test curve-3 (50Hz)
